# 15 YEARS LATER: ON THE PHYSICS OF HIGH-RISE BUILDING COLLAPSES

■ Steven Jones<sup>1</sup>, Robert Korol<sup>2</sup>, Anthony Szamboti<sup>3</sup> and Ted Walter<sup>4</sup>

On September 11, 2001, the world witnessed the total collapse of three large steel-framed high-rises. Since then, scientists and engineers have been working to understand why and how these unprecedented structural failures occurred.

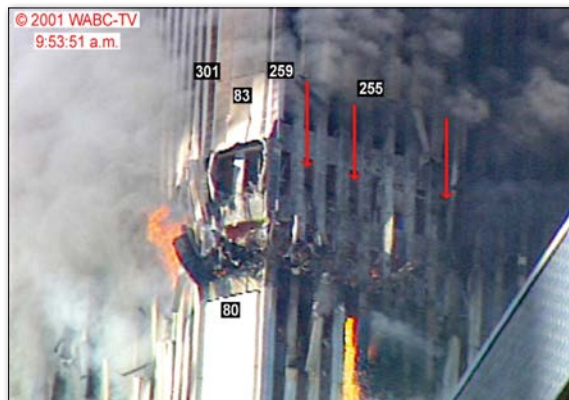
► **FIG. 6:** Molten metal was seen pouring out of WTC 2 continuously for the seven minutes leading up to its collapse (Sources: WABC-TV, NIST).

NIST sidesteps the well-documented presence of molten metal throughout the debris field and asserts that the orange molten metal seen pouring out of WTC 2 for the seven minutes before its collapse was aluminum from the aircraft combined with organic materials (see Fig. 6) [6]. Yet experiments have shown that molten aluminum, even when mixed with organic materials, has a silvery appearance—thus suggesting that the orange molten metal was instead emanating from a thermite reaction being used to weaken the structure [12]. Meanwhile, unreacted nano-thermitic material has since been discovered in multiple independent WTC dust samples [13].
